DEPARTMENT OF TRANSPORTATION

Quality Assurance and Source Inspection

WELDING INSPECTION REPORT

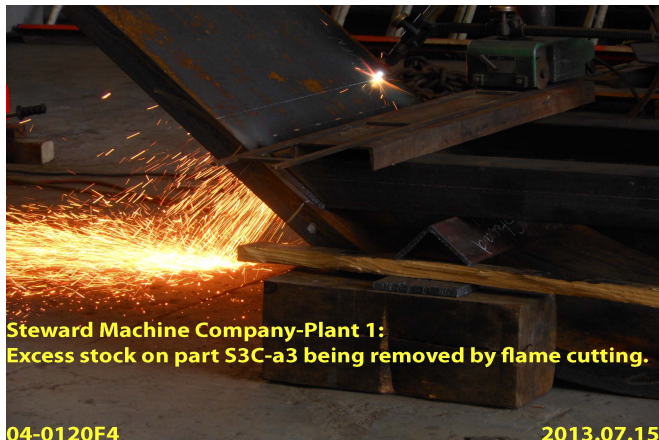
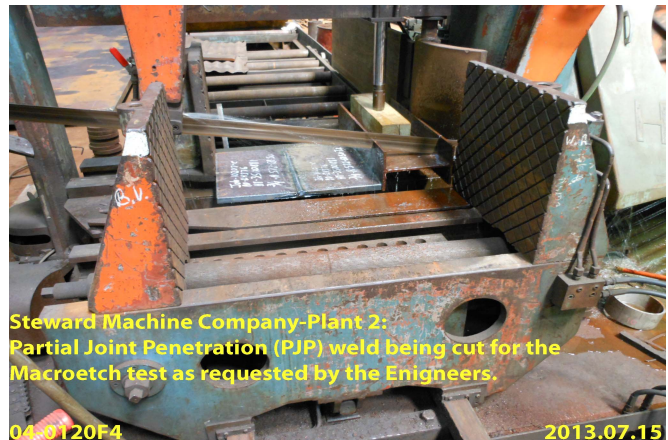
PJP Mock Up Weld Soundness Test:

The QA inspector was asked to witness the welding of the PJP mock up of the groove weld connecting the saddle ducts. The joint configurations had been changed and a mock-up was required by the Engineers utilizing the relevant Welding Procedure Specification (WPS) to verify weld details such as weld size, weld penetration, and to ensure no blow through would occur with the WPS used. The mock-up was welded by welder David Hyche (#37) utilizing weld filler metal designated as E70T-1 in accordance with the tables set forth in AWS D1.5. After preheating the assembly to 150 degrees Fahrenheit the welder began welding the root pass with the QC inspector observing and documenting the electrical parameters as 250 amps/29 volts. After QC Inspector Darrel Nix inspected the root pass he informed the welder to continue. After completing the welding of the mock-up, it was allowed to cool before three (3) Macroetch specimens were cut from it. Inspection of the Macroetch confirmed weld size, weld soundness and were acceptable as per AWS D1.5 section 5.19.3 with no blow through noted. Measurements were taken of the PJP welds and all sample penetration were from 14.5mm to 15mm deep and 19mm to 20mm wide. Mock up plate dimensions were 18" x 15" x 0.75"T with a groove angle of 30 degrees.
